• **Timber Frame Withstands Fire**

But Timber Hangar Frame Stands Up

T. K. May
Director of Technical Service
West Coast Lumbermen's Association
Portland, Oregon

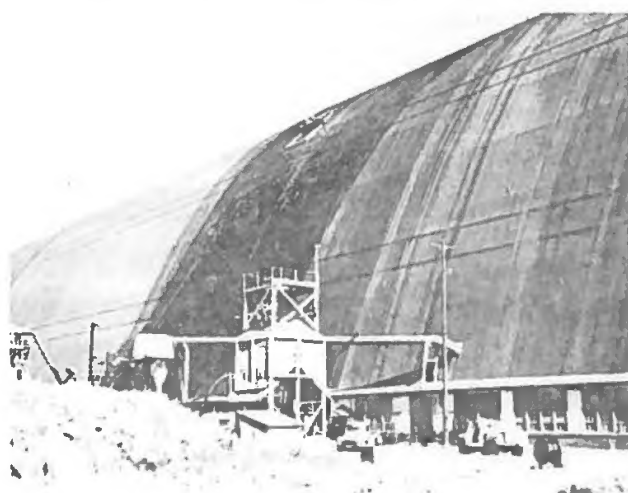
Fire . . .

Roofing material burned when residuals in plywood manufacturing facilities, now occupying former World War II blimp hangar at Tillamook, Ore., burst into flames

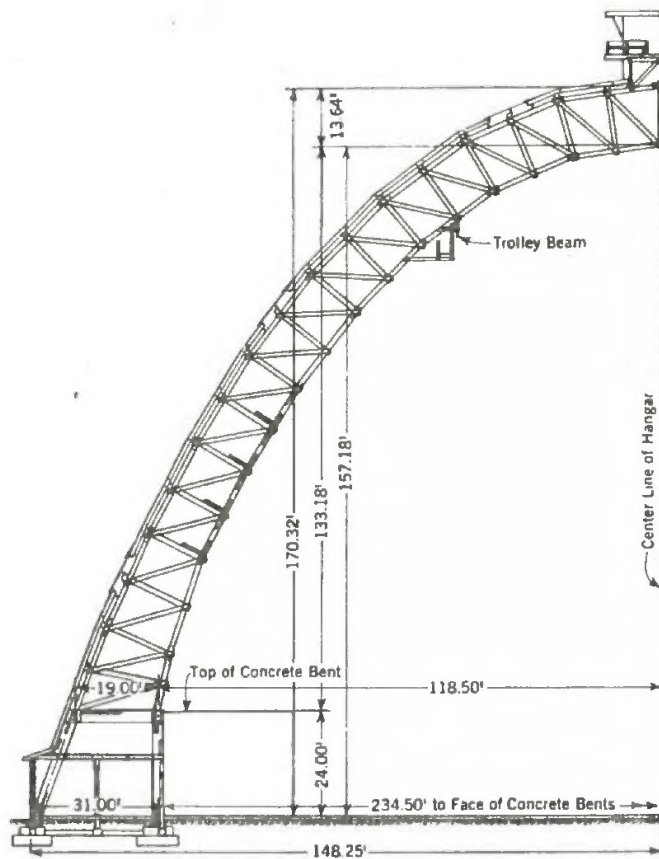
TYPICAL SECTION OF HANGAR

• **Design details**—The arch ribs are truss type, spaced on 20-ft centers, and supported on reinforced concrete abutment bents 24 ft in height. The trussed ribs are 18½ ft deep. Chords vary from two 3x12 to two 4x12 pieces and the web verticals from one 4x8 to one 6x18 piece while the web diagonals consist of two 3x8's.

Purlin trusses, 12 ft c to c, have a 3x10 top chord. The rafters are 3x12's, at about 7 ft spacing, and the roof is sheathed with 2-in. tongue-and-groove planking.
